Modifications to Post and Pier Foundation Retrofit for Residences with Sub-standard Crawl Space

**Supplemental Recommendations based on observation of a
Post and Pier Retrofit applied to a Pearl City single family home**

By: Ian Robertson, Ph.D., P.E.

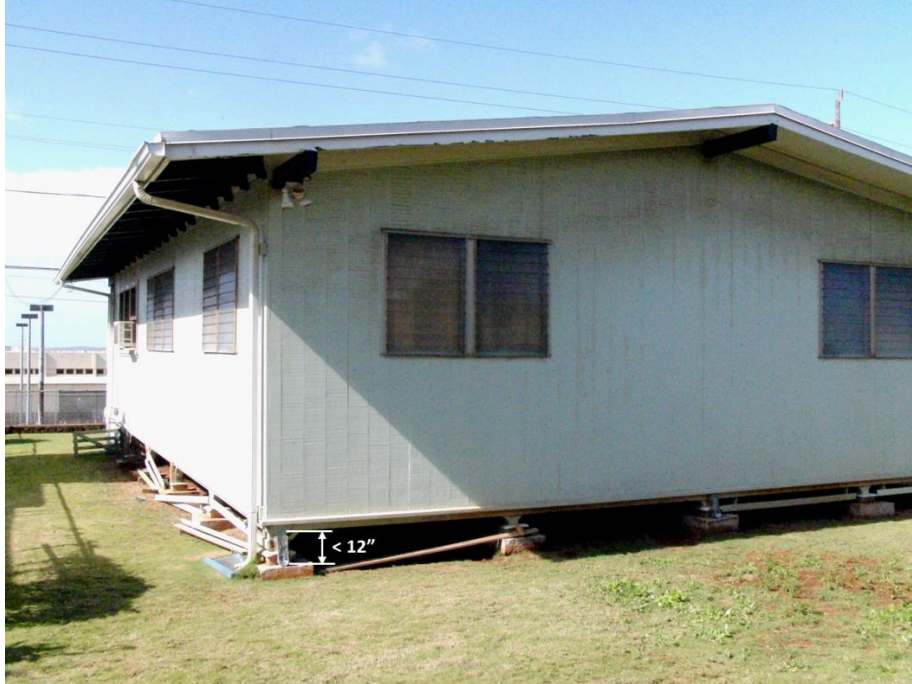
Figure 1: Single-wall home supported on post and pier foundations.

The post and pier retrofit described in this report was applied to a single family home in Pearl City on the island of Oahu, Hawaii. The building is a traditional single-story wooden single-wall structure built in 1962 with a floor area of 1064 sqft. The majority of the building is supported by post and pier foundations as shown in Figure 1. The crawl space below the elevated floor is considerably less than the 24” required by current codes, making it difficult to install the post and pier retrofit described in the retrofit report (FEMA, 2009).

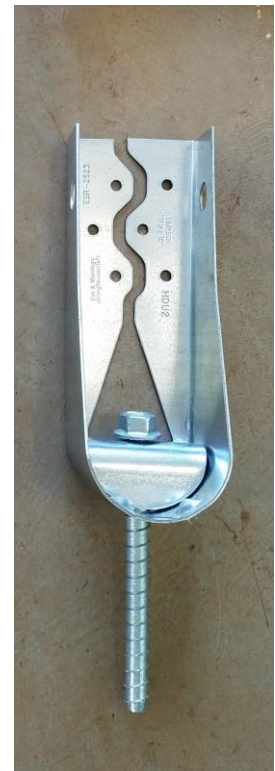
Figure 12 A Holddown with a heavy duty concrete screw anchor

Epoxied threaded rod anchor bolts (utilized in Figure 9) can be substituted by heavy duty screw anchors (shown in Figures 10, 11 and 12). The heavy duty screw anchors should be stainless steel and embedded at least 4 inches into the concrete footing. These should require less labor to install. Note that both require predrilling of the hole for the anchor bolt.

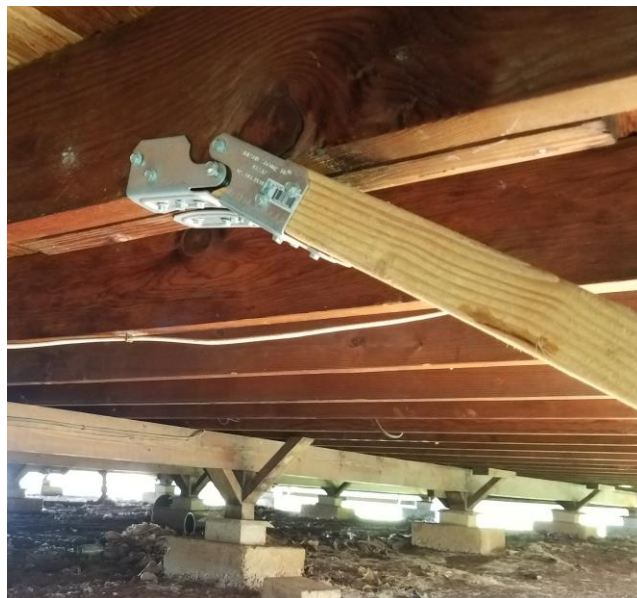
Figure 16: Two Knee-Brace Stabilizers, KBS1Z, connecting an interior brace to a floor joist.

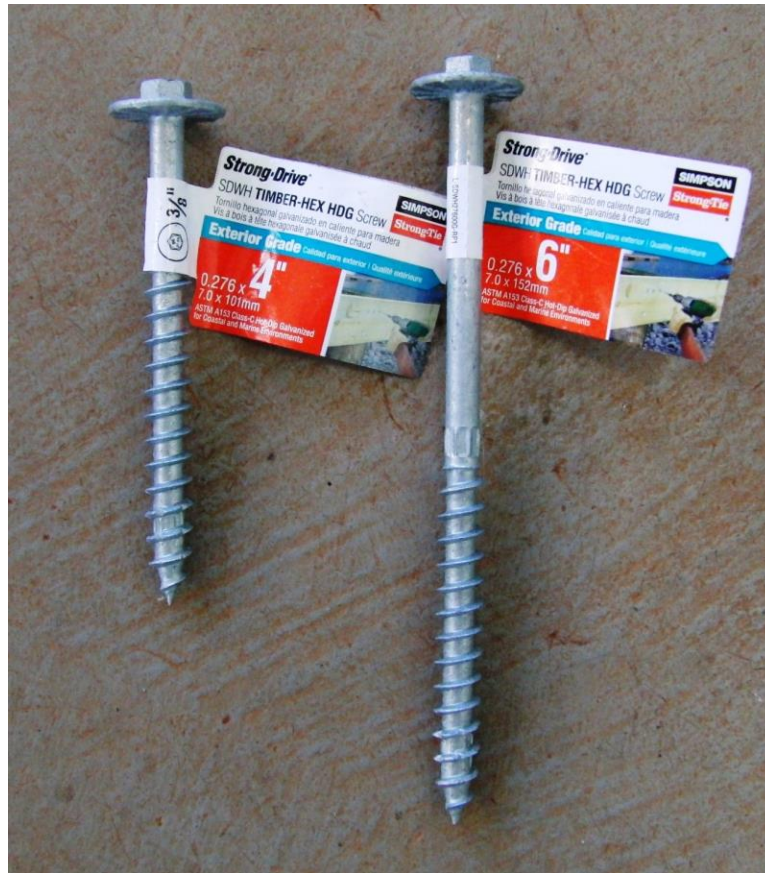
Figure 17: Simpson Strong-Drive SDWH Timber-Hex screws

An alternative for the end connections of the diagonal braces is the use of Strong-Drive SDWH timber screws as shown in Figure 17. These screws are available in various diameters and lengths, and are either hot-dipped galvanized (HDG) or Type 316 stainless steel (SS) for increased corrosion resistance. Four SDWH screws provide the same tensile capacity as two KBS1Z connectors. For brace ends that conflict with the post holdowns, or where installation of the KBS1Z connectors is not practical, SDWH

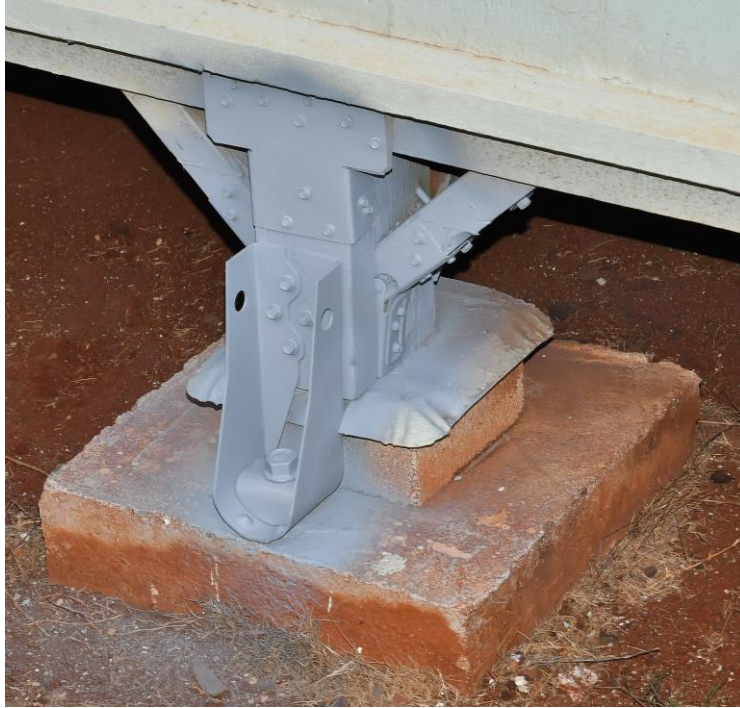
Figure 18: Galvanized connectors sprayed with zinc-rich cold-galvanizing paint to increase corrosion resistance. (To be followed by the second and third coats in the three-coat painting system)

For most locations, standard galvanized connector plates and fasteners (nails and screws) are adequate to provide protection against corrosion. However, for any locations close to the shoreline, it would be wise to consider using stainless steel connectors and fasteners. These are more expensive and may need to be special-ordered, but they will provide considerably longer life in coastal environments than the galvanized components. An intermediate alternative to extend the life of galvanized components is to first apply a coat of zinc-rich cold-galvanizing compound to the connectors and fasteners after installation as shown in Figure 18. Then, the connectors can now be painted with a three-coat system consisting of a 1) Zinc-Rich Epoxy Primer 3 to 5 mils thick, 2) an Epoxy Polyamide intermediate coat 3 to 5 mils thick, and 3) a Polyurethane Topcoat 2 to 3 mils thick. This coating system is considered appropriate for the coating of galvanized steel surfaces.
